**Flood Control Project Maintenance
Levee Inspections**

Fall 2019 Levee Maintenance Deficiency Summary Report

Levee District No. 0001 (Glenn County)

Waterway			Bank	Unit Miles
Unit No. 01 Sacramento River			Right	12.23
	Spring (March - May)	Summer (June - August)	(September - November) Fall	Winter (December - February)
Unit Maintenance Rating (Fall Only)			A	
Date of Inspection	4/26/2019 - 4/26/2019		9/17/2019 - 9/17/2019	
DWR Inspector	Makar Sokol		Makar Sokol	
Accompanied By	Nick Henning		Nick Henning	
	Nick Perez

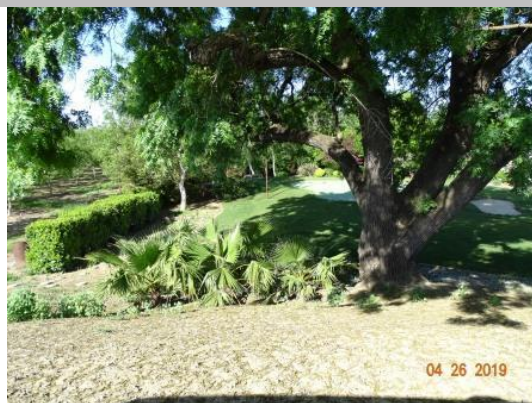
Photo 1 of 1 : FA_2019_LD0001G_432_53_20190822_00013.jpg

View of the palm trees at the landside toe. Spring 2019.

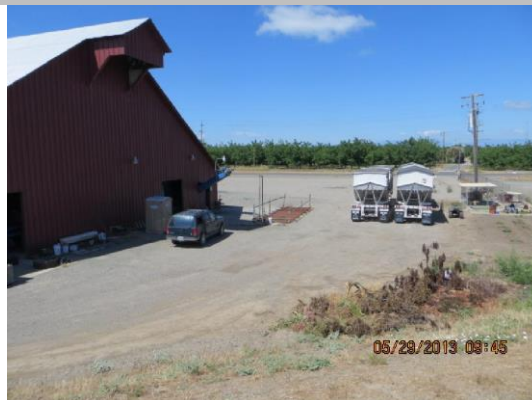
Photo 2 of 3 : UCIP_FA_2019_14324_23563.jpg

Concrete sump next to barn off LS toe.

Comment Code						
Inspector Comment						
DS_ID:22893						
FS_ID:14324						
EP_NO: 11782						
Repair Type: Non-Urgent						
Crossing Status: Found						
UCIP Comments: 5/29/2013 - Siphon breaker missing from WS shoulder (W. Wylie - DWR UCIP)						
FIELD_STRUCT_DESC: 3-inch galvanized steel water pipe through the levee, 2 feet below the crown. There is a hose bib style siphon breaker on the waterside (WS) shoulder. A pipe runs from the concrete sump next to the barn on the landside (LS) to a cesspool off of the WS toe. (Permit No. 11782, 1976 - Carriere Brothers). [Additional Reference(s): DWR Levee Log, 1992].						
FS Date: 5/29/2013

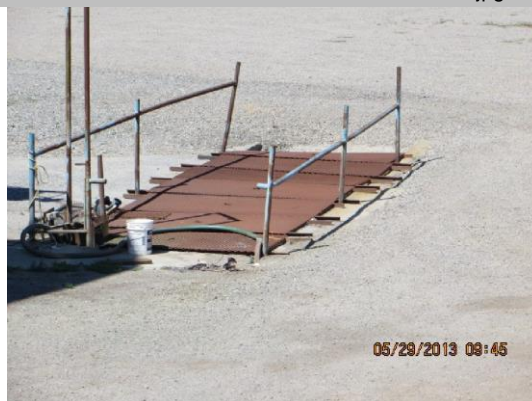
Photo 3 of 3 : UCIP_FA_2019_14324_23562.jpg

Concrete sump next to barn off LS toe.

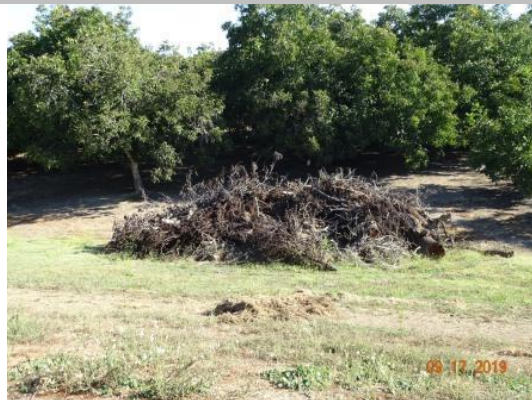
Photo 1 of 1 : FA_2019_LD0001G_432_41_20190918_00100.jpg

LM Start	0.77	Rating **	M	Issue No.	41
LM End	0.77	Issue Type +	En	Location *	WS
Category	Earthen Levee			GPS Latitude/Longitude	
				Start	End
Item	Encroachments			39.487890 °	39.487890 °
				-122.019529 °	-122.019529 °
DWR ID	DWR_LD0001G_01_f _ 2019_41				
Comment Code					
PR : Prunings					
Inspector Comment					
The pile of prunings should be removed from the waterside toe.

View of the prunings along the waterside toe. Fall 2019.

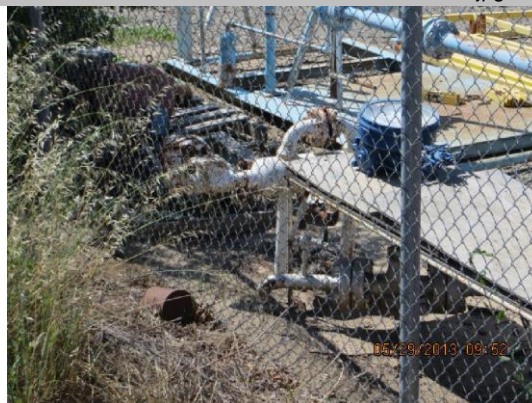
Photo 2 of 3 : UCIP_FA_2019_14325_23567.jpg

Possible pipe at crossing, LS toe.

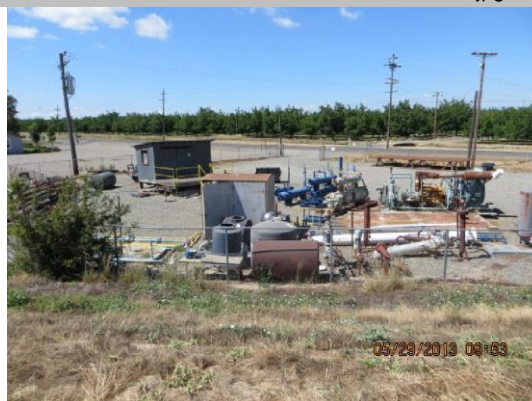
Photo 3 of 3 : UCIP_FA_2019_14325_23566.jpg

Gas pumping plant and appurtenances.

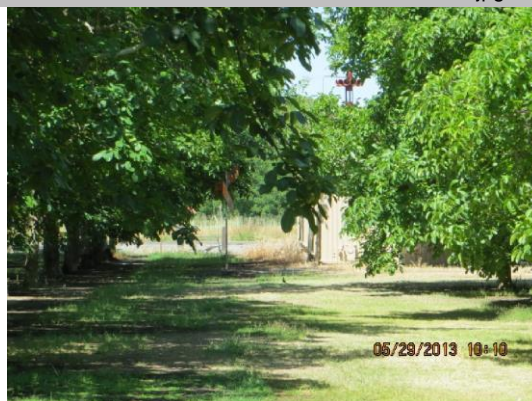
Photo 1 of 1 : UCIP_FA_2019_14327_23569.jpg

Gasline markers near where removed pumping plant was located.

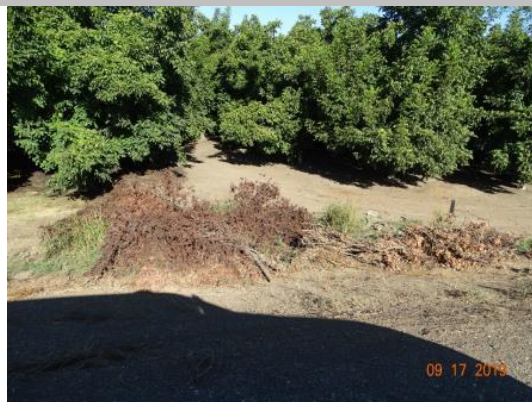
Photo 1 of 1 : FA_2019_LD0001G_432_64_20190918_00101.jpg

LM Start	1.25	Rating **	M	Issue No.	64
LM End	1.25	Issue Type +	En	Location *	LS
Category	Earthen Levee			GPS Latitude/Longitude	
				Start	End
Item	Encroachments			39.494080 °	39.494080 °
				-122.018329 °	-122.018329 °
DWR ID	DWR_LD0001G_01_f _ 2019_64				
Comment Code					
PR : Prunings					
Inspector Comment					
The pile of prunings should be removed from the landside slope and toe.

View of the pile of prunings along the landside slope and toe. Fall 2019.

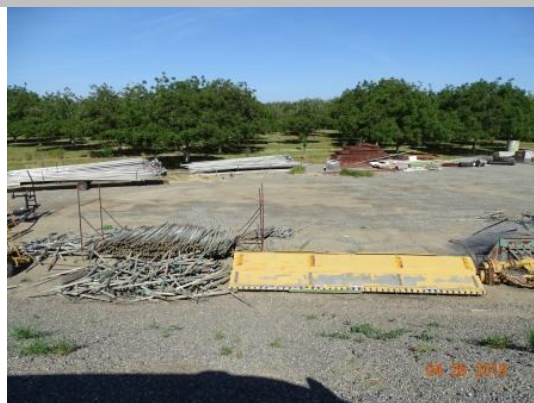
Photo 1 of 1 : FA_2019_LD0001G_432_71_20190822_00022.jpg

View of the farm equipment and materials at the landside toe. Spring 2019.

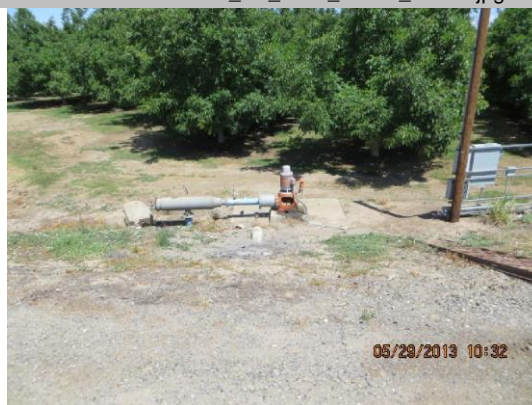
Photo 1 of 2 : UCIP_FA_2019_14331_23579.jpg

Pump at LS toe with no connection to 8-inch pipe.

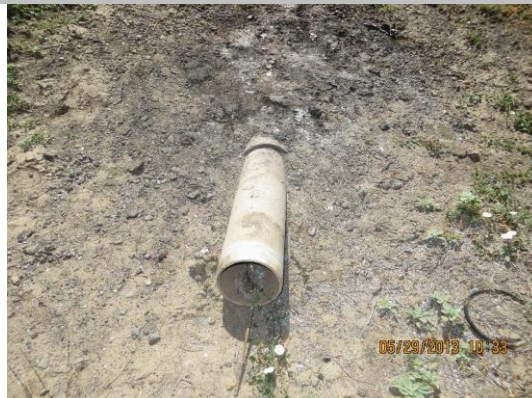
Photo 2 of 2 : UCIP_FA_2019_14331_23578.jpg

8-inch pipe visible at LS toe.

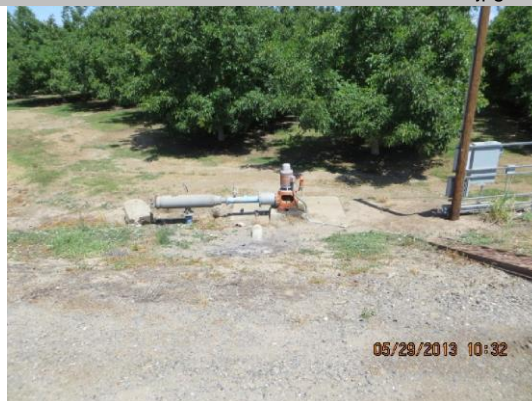
Photo 1 of 3 : UCIP_FA_2019_14332_23582.jpg

LM Start	2.22	Rating **	M	Issue No.	402
LM End	2.22	Issue Type +	Ma	Location *	
Category	Supplemental			GPS Latitude/Longitude	
				Start	End
Item	DRAFT DWR UCIP LMA Responsibility			39.501690 °	39.501690 °
				-122.006099 °	-122.006099 °
DWR ID	22944				
Comment Code					
Inspector Comment					
DS_ID:22944					
FS_ID:14332					
EP_NO: N/A					
Repair Type: Non-Urgent					
Crossing Status: Found					
UCIP Comments: Appears abandoned and should be done so properly.					
FIELD_STRUCT_DESC: *ABANDONED* 8-inch drainage pipe of an unknown material sleeved through a 12-inch pipe of an unknown material through the levee, 9.5 feet below the crown. Flap gate located on the waterside (WS). Pipe open on the landside (LS). [Additional Reference(s): USACE Sacramento O&M Manual 140, May 1960, (HLM 2.27)].					
FS Date: 5/29/2013

Pump at location of pipe on LS toe.

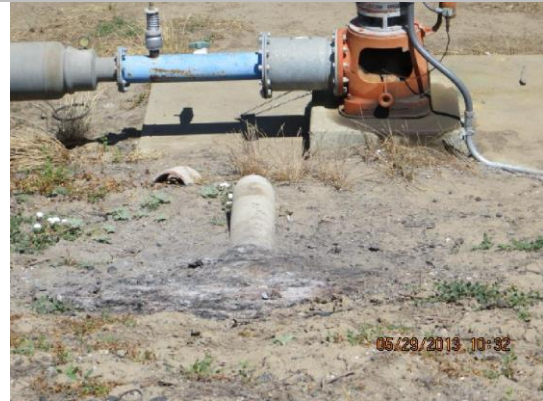
Photo 2 of 3 : UCIP_FA_2019_14332_23581.jpg

Pipe next to pump at LS toe.

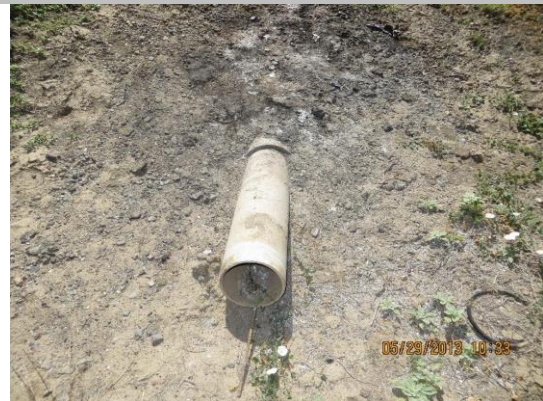
Photo 3 of 3 : UCIP_FA_2019_14332_23580.jpg

8-inch pipe sleeved through a 12-inch concrete pipe.

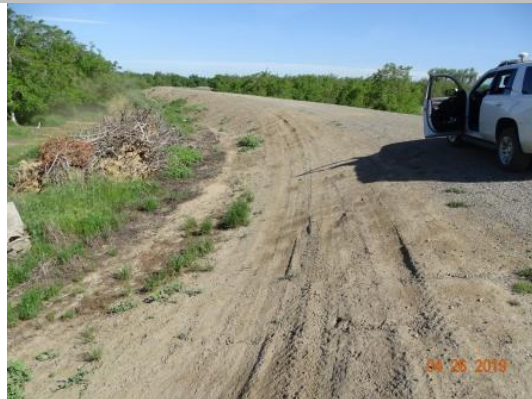
Photo 1 of 1 : FA_2019_LD0001G_432_77_20190822_00025.jpg

LM Start	3.04	Rating **	M	Issue No.	77
LM End	3.04	Issue Type +	Ma	Location *	LS
Category	Earthen Levee			GPS Latitude/Longitude	
				Start	End
Item	Slope Stability			39.512932 °	39.512932 °
				-122.009074 °	-122.009074 °
DWR ID	DWR_LD0001G_01_s_2019_77				
Comment Code					
S3 : Repair the levee slope damaged by vehicle traffic and prevent access where possible.					
Inspector Comment

View of the landside slope damaged by vehicle traffic. Spring 2019.

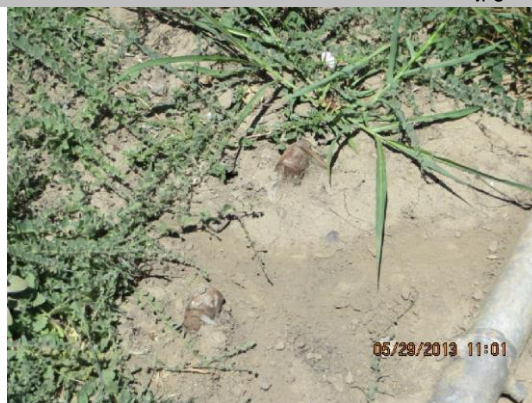
Photo 1 of 2 : UCIP_FA_2019_54250_27343.jpg

Flap gate visible at WS toe.

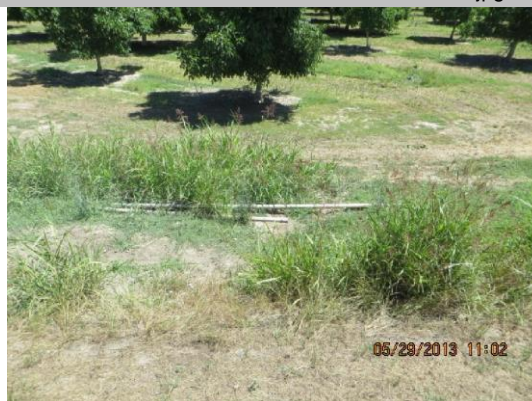
Photo 2 of 2 : UCIP_FA_2019_54250_27342.jpg

Flap gate visible at WS toe.

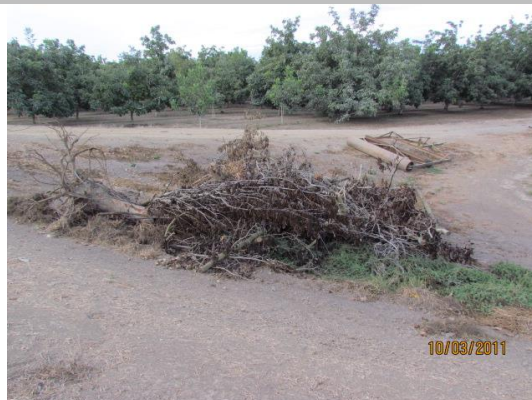
Photo 1 of 1 : FA_2019_LD0001G_432_16_20190822_00006.jpg

LM Start	3.19	Rating **	M	Issue No.	16
LM End	3.19	Issue Type +	En	Location *	LS
Category	Earthen Levee			GPS Latitude/Longitude	
				Start	End
Item	Encroachments			39.514709 °	39.514709 °
				-122.010515 °	-122.010515 °
DWR ID	DWR_LD0001G_01_s_2012_16				
Comment Code					
PR : Prunings					
Inspector Comment					
Prunings should be removed from the landside toe.

View of the pruning pile along the LS toe.

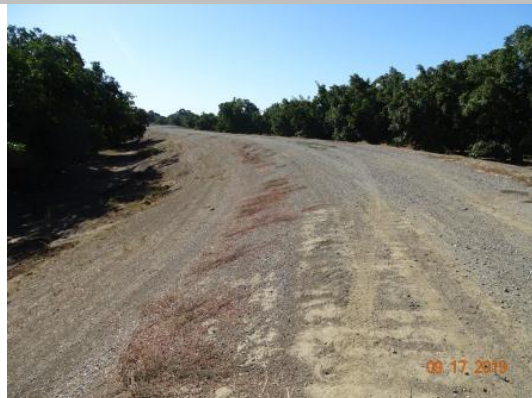
Photo 1 of 1 : FA_2019_LD0001G_432_68_20190918_00102.jpg

LM Start	3.26	Rating **	M	Issue No.	68
LM End	3.26	Issue Type +	Ma	Location *	WS
Category	Earthen Levee			GPS Latitude/Longitude	
				Start	End
Item	Slope Stability			39.515595 °	39.515595 °
				-122.011152 °	-122.011152 °
DWR ID	DWR_LD0001G_01_f _ 2019_68				
Comment Code					
S3 : Repair the levee slope damaged by vehicle traffic and prevent access where possible.					
Inspector Comment

View of the waterside slope damaged by vehicle traffic. Fall 2019.

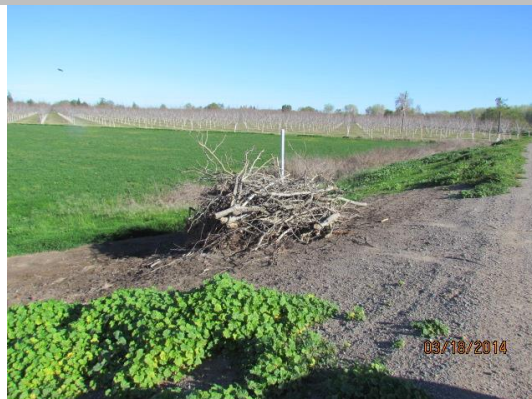
Photo 1 of 1 : FA_2019_LD0001G_432_46_20190822_00009.jpg

LM Start	3.39	Rating **	M	Issue No.	46
LM End	3.39	Issue Type +	En	Location *	LS
Category	Earthen Levee			GPS Latitude/Longitude	
				Start	End
Item	Encroachments			39.517389 °	39.517389 °
				-122.010685 °	-122.010685 °
DWR ID	DWR_LD0001G_01_s_2016_46				
Comment Code					
PR : Prunings					
Inspector Comment					
Prunings should be removed from the landside slope.

View of the prunings along the landside slope.

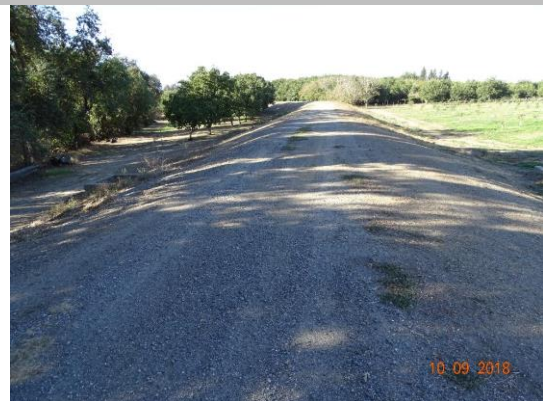
Photo 1 of 3 : UCIP_FA_2019_53006_78123.jpg

View of levee crown at the crossing.

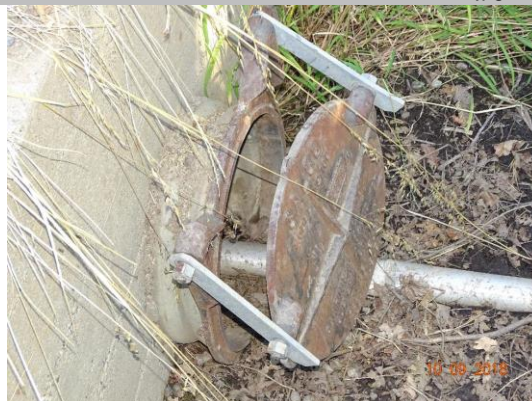
Photo 3 of 3 : UCIP_FA_2019_53006_78125.jpg

Comment Code					
Inspector Comment					
DS_ID:22904 FS_ID:53006 EP_NO: 9572 Repair Type: Urgent Crossing Status: Found UCIP Comments: 10/9/2018 No change to the crossing status. Flap gate on WS cannot be fully closed due to a 3-inch pipe through drainage pipe crossing the levee. Water is supplied from a well on LS via 3-inch pipe to the WS for irrigation/drinking purposes. Owner will need to remove obstruction to allow proper flap gate closure. (O.Yakimov - DWR UCIP)12/21/2016 Flap gate on WS does not appear to be broken however, flap gate does not fully close due to a 3-inch aluminum pipe sleeve through larger pipe. Need to remove 3-inch pipe in order to have WS flap gate close and to be compliant with Title 23. (O. Magana - DWR UCIP)05/29/2013 Broken flap gate and Concrete headwall on LS toe possibly tilting. Also a 3-inch alluminum irrigation line through the pipe. (W. Wylie - DWR UCIP) FIELD_STRUCT_DESC: 18-inch steel drainage pipe through the levee, 7.3 feet below the crown. Flap gate in 6-inch by 6-inch concrete box located on the waterside (WS) end. Concrete headwall located on the landside (LS) toe. (18-inch pipe [HLM 4.05] authorized under Automatic Board Order (ABO) issued as Permit No. 9572, 1974 - Henry and Annabel B. Smith). [Additional Reference(s): DWR Levee Log, 1992. USACE Sacramento O&M Manual 140, May 1960, (HLM 4.05)]. FS Date: 10/9/2018 3:27:06 PM

3-inch pipe obstructs flap gate from complete closing.

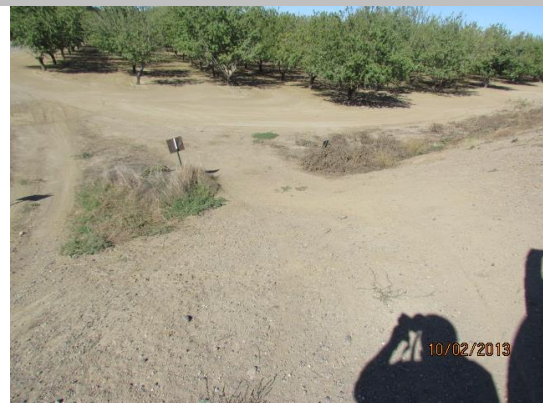
Photo 1 of 1 : FA_2019_LD0001G_432_57_20190822_00016.jpg

View of the vehicle erosion along the slope of the levee.

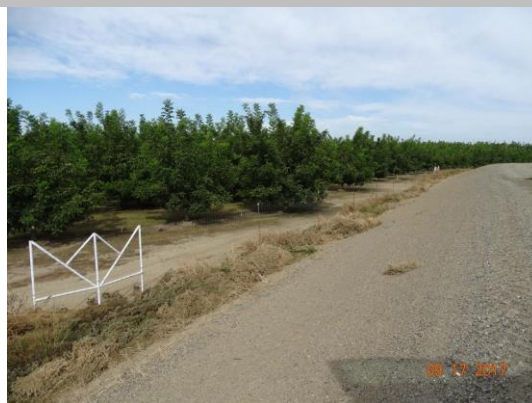
Photo 1 of 1 : FA_2019_LD0001G_432_78_20190822_00026.jpg

View of the fence along the landside toe.

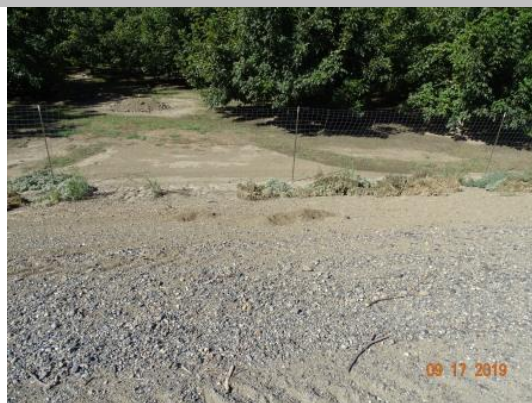
Photo 1 of 1 : FA_2019_LD0001G_432_84_20190918_00103.jpg

View of the rodent activity on the landside slope. Fall 2019.

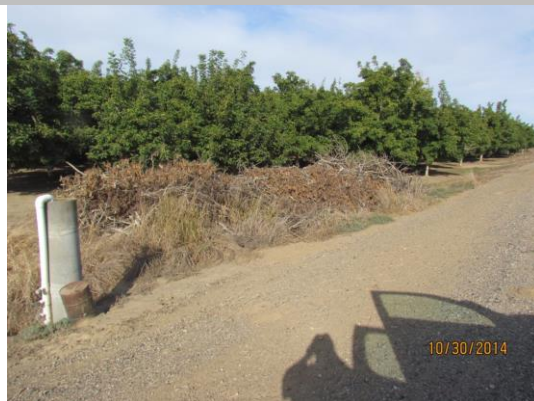
Photo 1 of 1 : FA_2019_LD0001G_432_54_20190822_00014.jpg

View of the prunings along the landside toe.

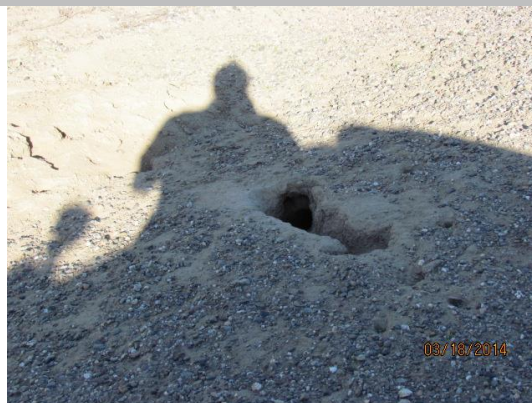
Photo 1 of 1 : FA_2019_LD0001G_432_47_20190822_00010.jpg

View of the rodent activity along the LS slope.

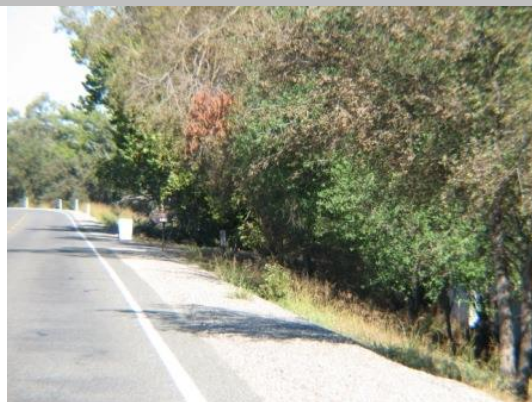
Photo 1 of 1 : FA_2019_LD0001G_432_20_20190822_00007.jpg

View of the trees and vegetation along the waterside slope of the levee.

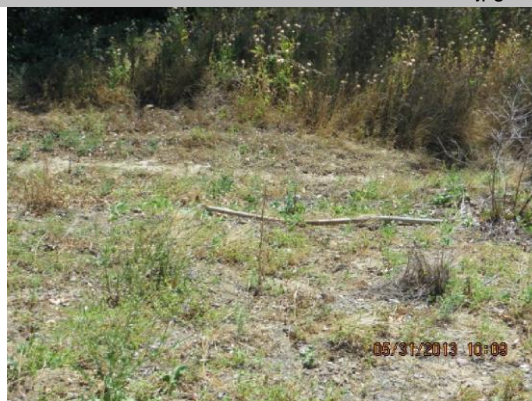
Photo 3 of 3 : UCIP_FA_2019_16204_27328.jpg

Pipe debris on WS slope may be indicator of pipe location on WS.

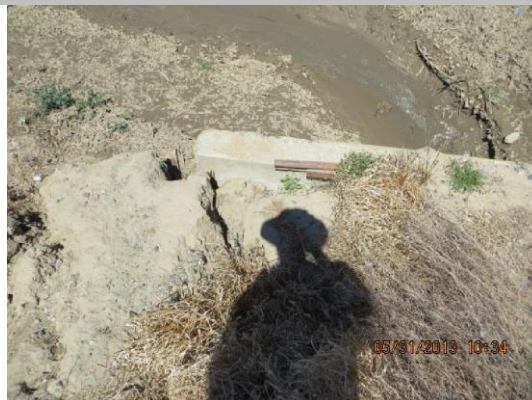
Photo 3 of 3 : UCIP_FA_2019_14390_23688.jpg

Erosion around headwall at LS toe.

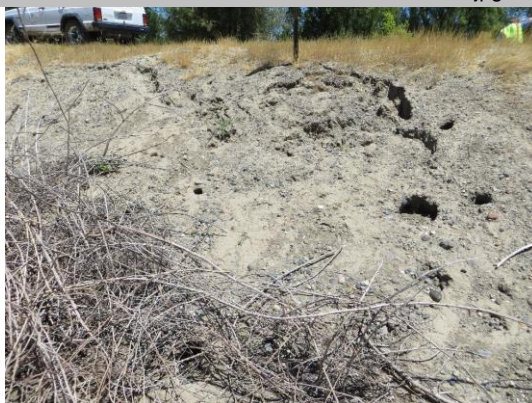
Photo 3 of 3 : UCIP_FA_2019_14567_24015.jpg

Erosion and sloughing on LS slope possibly due to rodent activity.
